Manhole Inspection Summary

Manhole # S31GG1025MH

Location Address: **102 39TH ST**

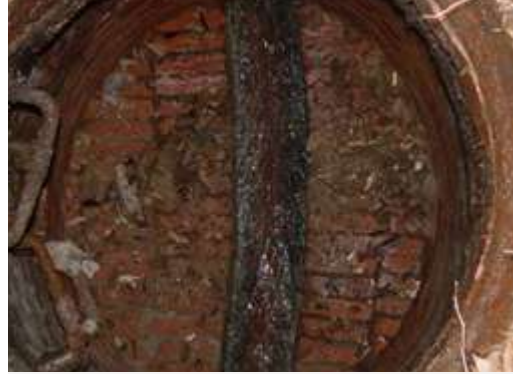
Top View

Barrel infiltration. Corroded steps.
Evidence of surcharge - Bench debris.

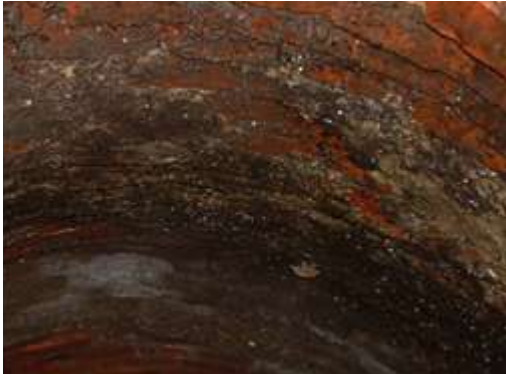
Defect

Condition: ☐ Sound ☐ Cracked ☒ **Root Intrusion** ☐ Loose Brick ☐ Deteriorated

Infiltration: ☐ None ☒ **Joint** ☐ Cracks ☐ Mortar ☒ **Roots** ☒ **Wall**

Adjustment root intrusion and infiltration.
Corbel infiltration.

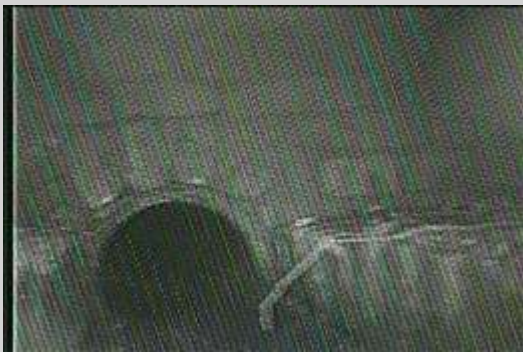
8 in. Circular Gravity Sewer Pipe Out @ 12 O'Clock

Infiltration: **Evidence** Pipe Seal Cond: **Unknown**

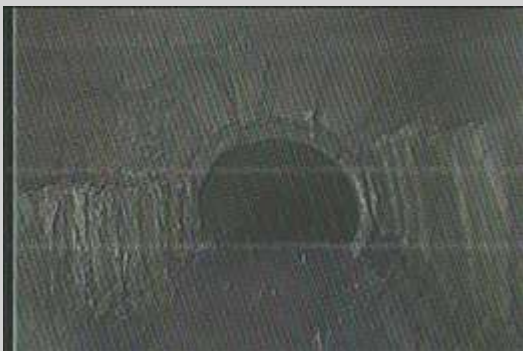
8 in. Circular Gravity Sewer Pipe In @ 6 O'Clock

Infiltration: **Evidence** Pipe Seal Cond: **Cracked**
